Double Arch Mirror Study
Part 3, Fabrication and Test Report

Daniel Vukobratovich
Don Hillman
University of Arizona

Daniel Vukobratovich
Don Hillman
University of Arizona
Optical Sciences Center

Prepared for
Ames Research Center
under Grant NAG2-220

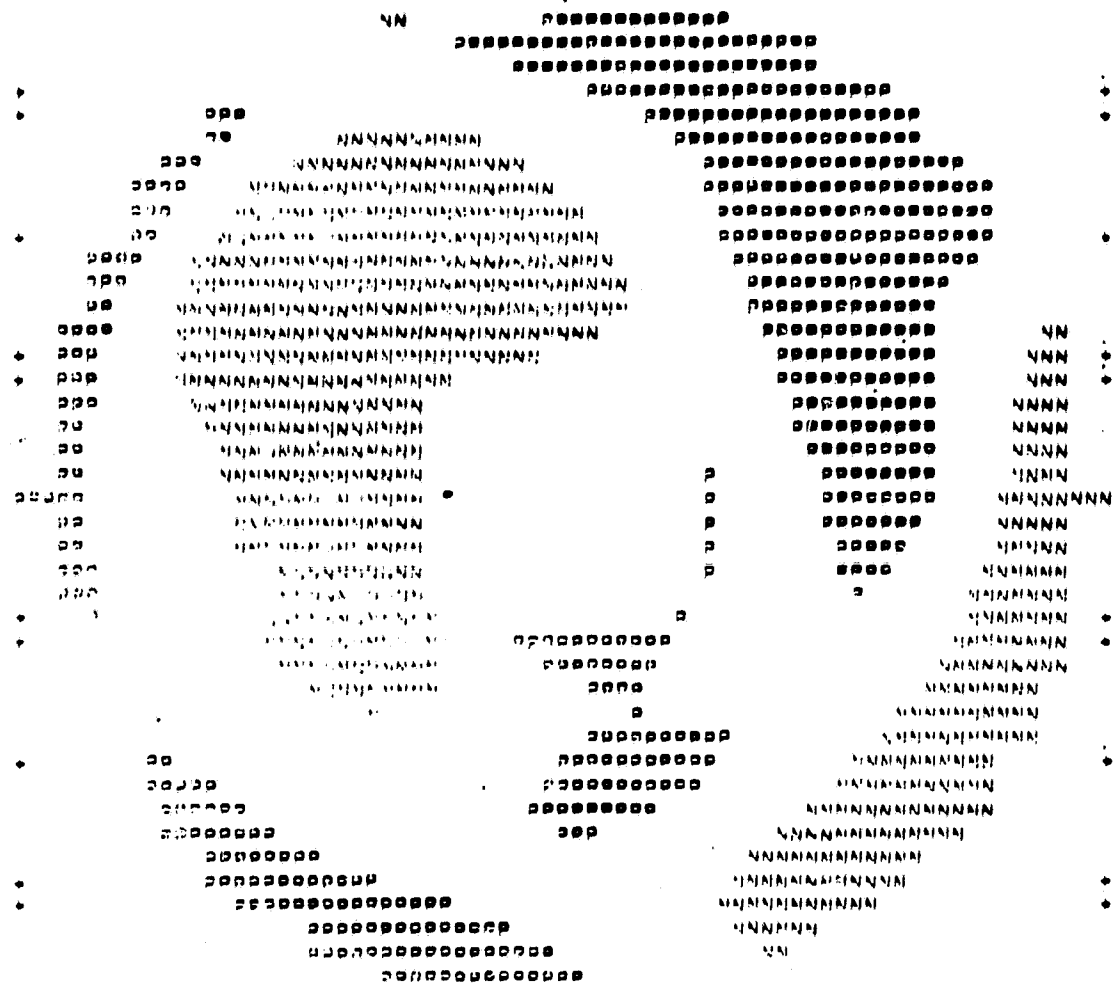
RTS	RMS	MAX	MIN	SPAN	VOLUME
664.	0.117	0.649	-0.052	0.121	0.153

Fig. 8. Mirror figure after modification. Mirror on its back, back continuously supported.

After socket fabrication was complete, the mirror was removed from the tooling plate, and the protective wax removed from the optical surface. The weight of the mirror following modification was 34 lbs. The mirror was cleaned, and tested to see if the optical figure had changed. The optical test set-up was identical to that used earlier, as was the test procedure. The results of this test can be seen in Fig. 8. The RMS surface error was now 0.017 waves, and the peak-to-valley error was 0.121 waves. The surface figure had changed from the original RMS and peak-to-valley figures. The improvement was by a factor of 2.6. Since the original fabrication of the double arch mirror had included an acid-etch stress relief, it is difficult to understand what led to the figure improvement. It is possible that lack of flatness of the back of the mounting ring could have led to excessive deformation, although the use of the compliant rubber pad for support should have eliminated this effect. The improvement is of the same order as the measurement error and is therefore somewhat suspect.

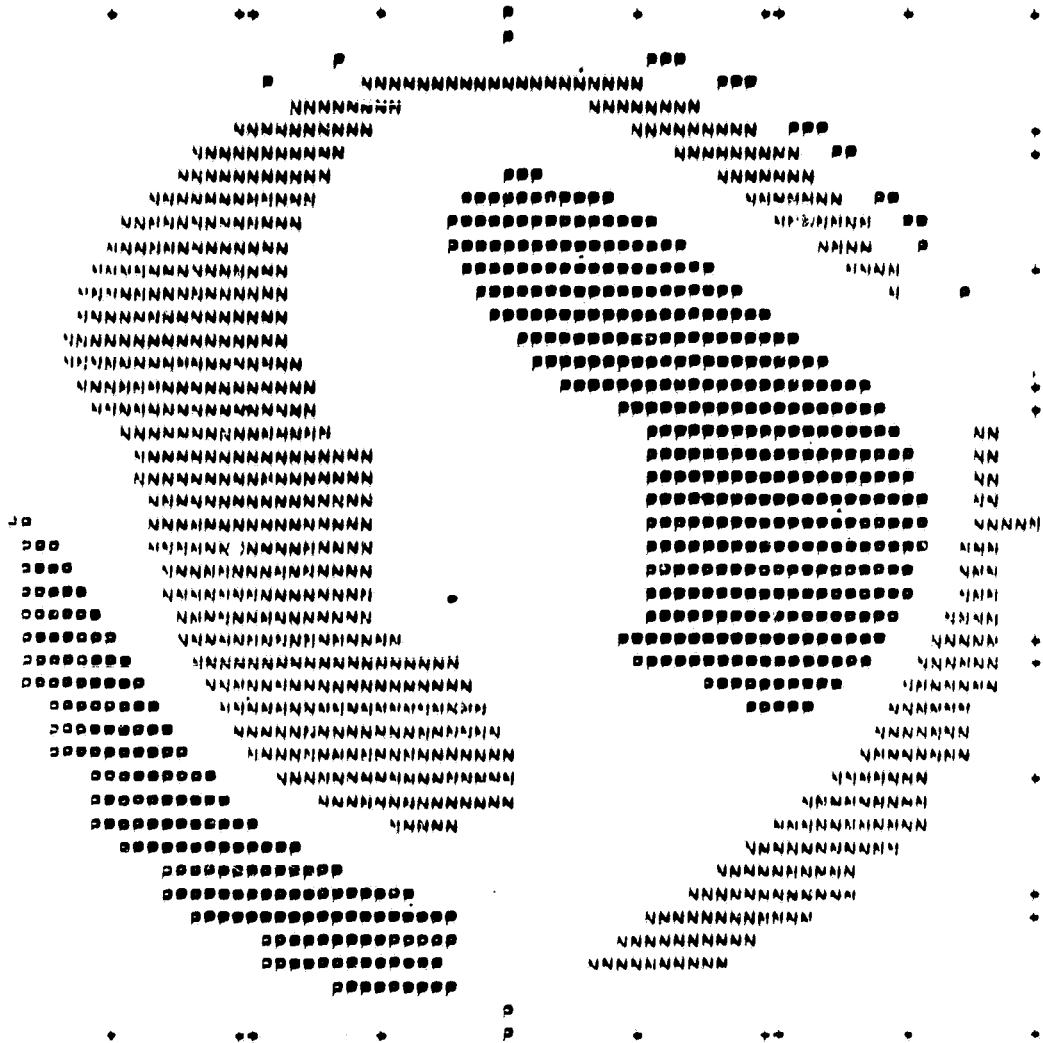
<u>PTS</u>	<u>RMS</u>	<u>Max.</u>	<u>Min.</u>	<u>Span</u>	<u>Volume</u>
664.0	0.017	0.061	-0.048	0.109	0.142

Fig. 11. Mirror under test upside down, stressed.

The translation stages were then driven 0.029 in. to simulate a cryogenic contraction of the aluminum baseplate. This corresponded to a 10°K final temperature. The results of this test are seen in Fig. 11. The RMS surface error is 0.017 waves and the peak-to-valley error is 0.109 waves. Again, there is no apparent print-through of the three support points.
